Bloch Wind Farm

Technical Appendix 9.6: Watercourse Assessment

October 2022

Document Number: 1296216

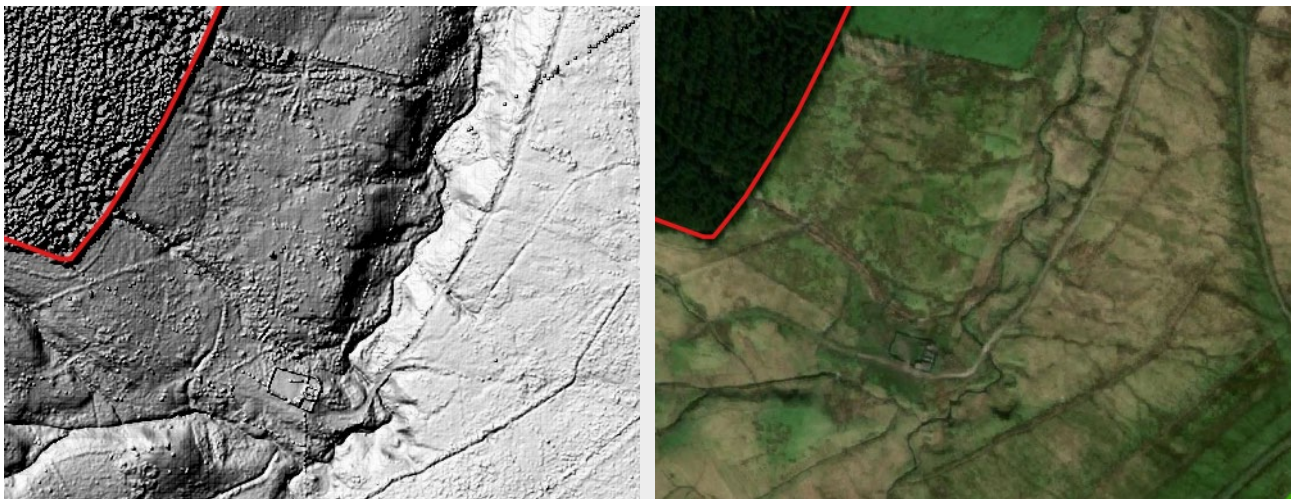
Natural watercourse channels were also identifiable on the LiDAR and aerial imagery (Figure Insert 3.2) and were mapped concomitant to features shown on the 1:25,000 scale OS and 1:50,000 scale OS. Watercourses were typically sinuous in lower reaches and more linear through steeper terrain. The topography surrounding the watercourse was also often reflective of its geometry, occupying re-entrant type features with nearby slopes also reflecting any associated sinuosity.

Figure Insert 3.2: LiDAR imagery (left) and aerial imagery (right) illustrating watercourse features (image of Back Burn)

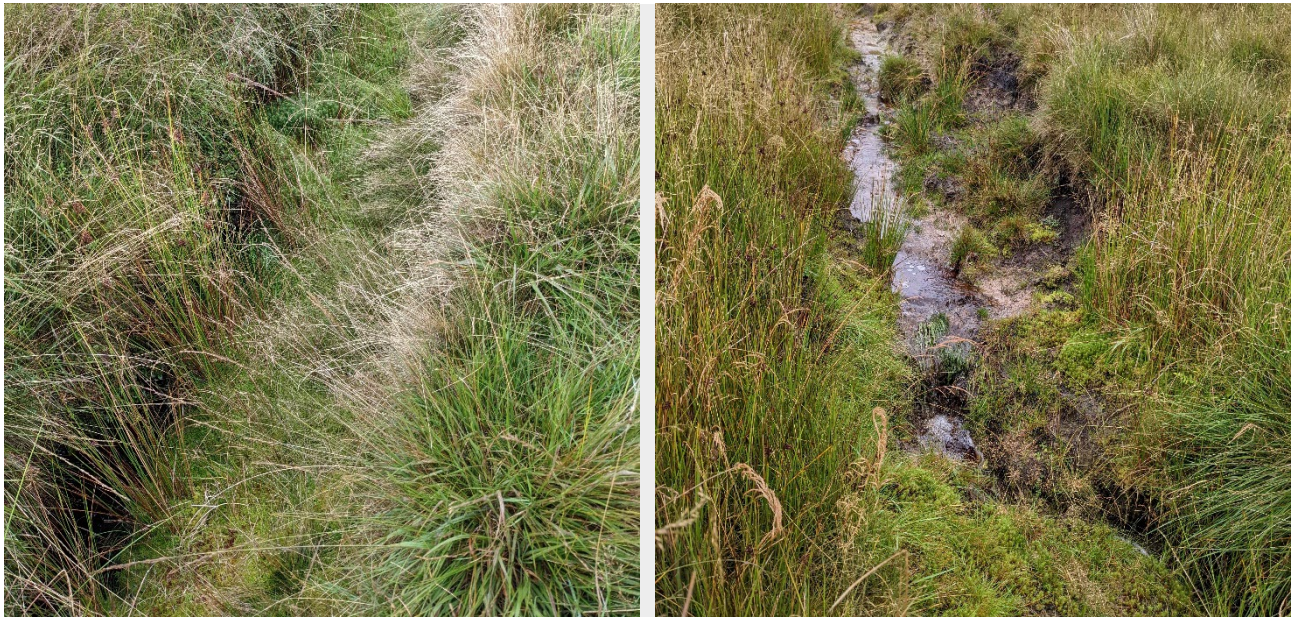
Artificial drainage networks were evident across the site. The majority of artificial ditches were dry or stagnant, apart from where these occurred on steeper slopes where they were slightly scoured, and some flow was evident. The bed of the artificial ditches was generally vegetation, but occasionally exposed subsoil or peat was identified.

Anecdotal information indicates that a small number of the ditches are regularly cleared as part of the baseline land use for agriculture, with more recently excavated sections also demonstrating a very low level of flow. Figure insert 3.3 illustrates ditches surveyed during the hydrological walkover.

Figure Insert 3.3: Photographs of an artificial ditch recently cleared for land use (left) and of a heavily vegetated ditch which was dry / stagnant

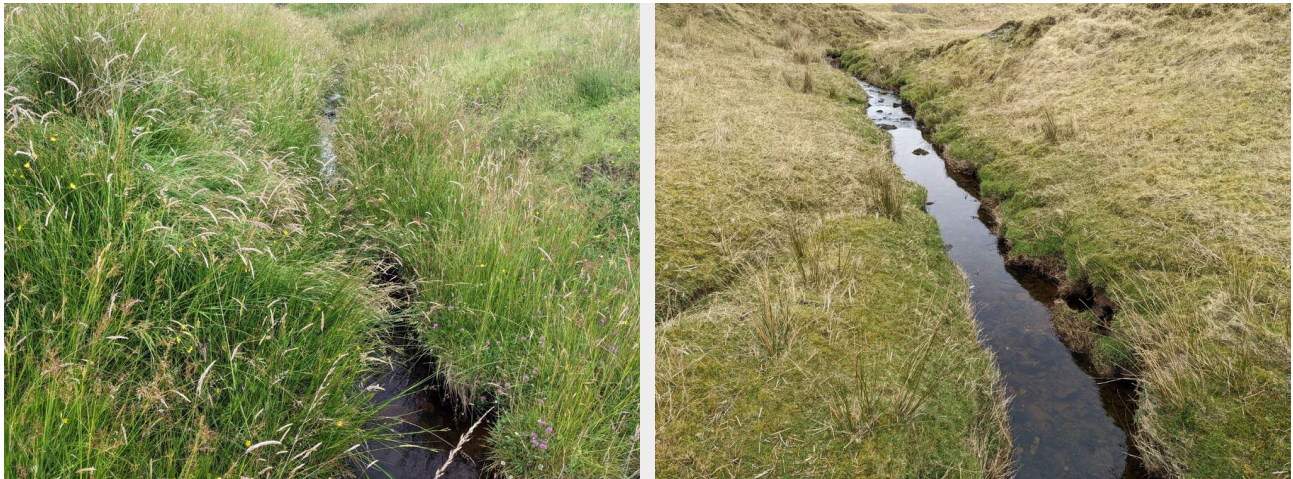
Apart from artificial drainage ditch tributary confluences and the effects of heavy grazing in riparian zones, the form of mapped watercourses was generally unmodified. Typically, these watercourses were incised into the subsoil with the bed being sub-soil or more commonly bedrock and gravel.

Watercourses occupied topographical re-entrant features ranging from shallow to more pronounced vee shape. Where watercourses were mapped as terminating on 1:25,000 scale OS or 1:50,000 scale OS, channels became more poorly defined and in some cases were connected to a network on drainage ditches which were often noted as dry. Flow within headwater channels appeared to be derived through diffusely emerging groundwater, drainage or seepage from upgradient areas of topographical convergence and occasionally drainage from recently cleared artificial ditches.

Figure Insert 3.4: Photographs of the Back Burn (left) at E330962, N580234 and Bloch Burn (right) at E333282, N581957.

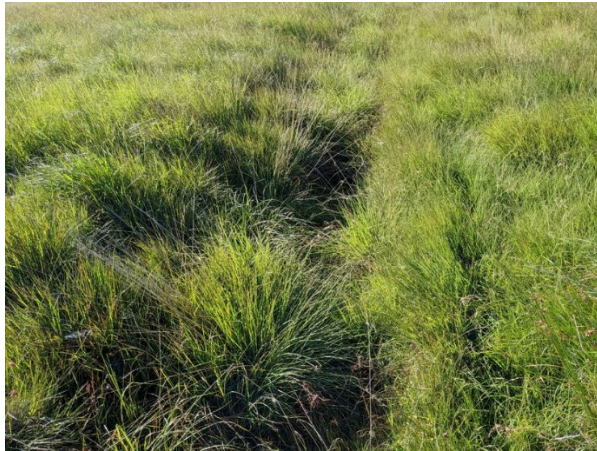
T3 (331233, 579934)

- Survey undertaken to characterise watercourse tributary shown on 1:10,000 scale map and noted absent from 1:25,000 and 1:50,000 scale OS.
- Desktop assessment using LiDAR and aerial imagery identified high number of artificial drainage ditches within the vicinity all draining into the Hope Burn (upper Back Burn).
- Site walkover identified a vegetation filled artificial ditch that was dry with no evidence of flow. Artificial ditch appears to confluence with the Hope Burn ~200m to the west. Hope Burn is a natural watercourse channel and is outside the buffer.
- As the mapped ditch is artificial and it is evidentially not a watercourse, the ditch would be blocked at the point of overlap during construction of T3.
- Surrounding habitat noted as M25 (modified bog) and around ditch may benefit from ditch blocking.

It is proposed that the identified artificial ditch networks at T3 and crane hardstand, T5 and crane hardstand and T18 and crane hardstand would be blocked during the construction of the proposed development to protect downgradient / downstream receptors. No artificial ditch or other hydrological network could be identified at T17. The blocking of these ditches would be undertaken in accordance with good practice mitigation outlined in Section 9.7 Mitigation, detailed in Chapter 9 of the EIA Report. Further information including method statements and site-specific environment management plans would be provided in the CEMP prior to construction.

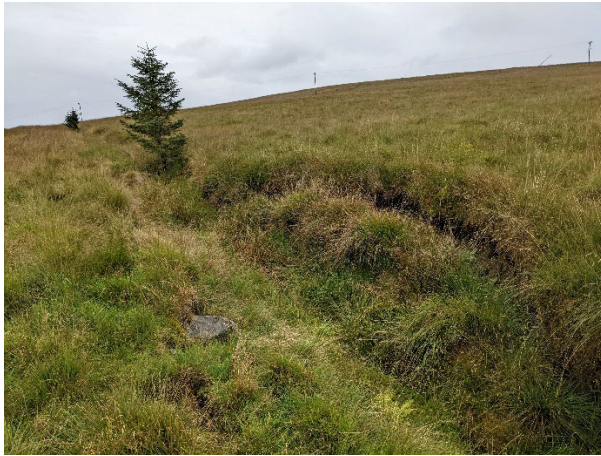
T5 (330260, 580468)

- Survey undertaken to characterise watercourse tributary shown on 1:10,000 scale map and noted absent from 1:25,000 and 1:50,000 scale OS.
- Desktop assessment using LiDAR and aerial imagery identified high number of artificial drainage ditches within the vicinity all draining into the Collin Burn.

- Site walkover identified a vegetation filled artificial ditch that was dry with no evidence of flow close to proposed turbine. Further down ditch had been recently excavated. Artificial ditch confluences with the Collin ~400m to the west. Collin Burn and the lower section of the confluence which the artificial ditch is connected to is a natural watercourse channel and is outside the buffer.

- Surrounding habitat noted as M25 (modified bog) and may benefit from ditch blocking.

- As the mapped ditch is artificial and it is evidentially not a watercourse, the ditch would be blocked at the point of overlap during construction of T5.

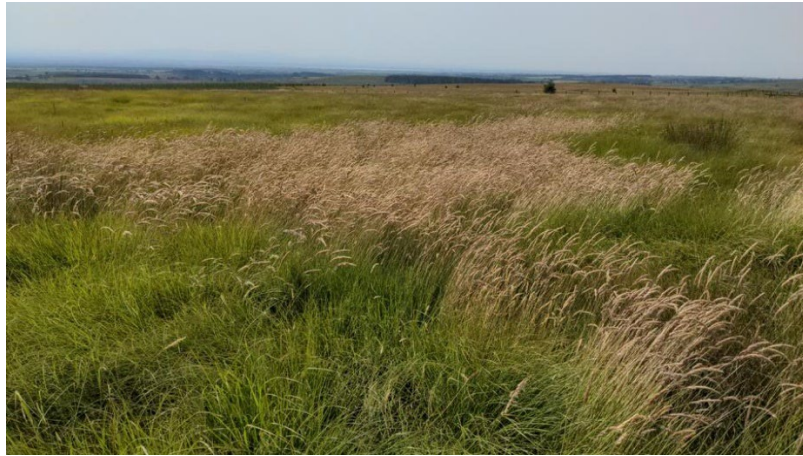
T17 (334128, 580901)

- Survey undertaken to characterise watercourse tributary shown on 1:10,000 scale map and noted absent from 1:25,000 and 1:50,000 scale OS.
- Desktop assessment using LiDAR and aerial imagery identified high number of artificial drainage ditches all draining into a tributary of the Bigholm Sike.
- The site walkover identified no drainage network at the proposed turbine location. Approximately 100m to the west the ditch became more pronounced. The artificial ditch confluences with a headwater tributary of the Bigholm Sike ~300m to the west. The Bigholm Sike is a natural watercourse channel and is outside the buffer.
- As the mapped ditch is ~100m from the proposed turbine and is also artificial, no specific consideration is required.
- Surrounding habitat noted as M25 (modified bog) and where the ditch becomes pronounced may benefit from ditch blocking.

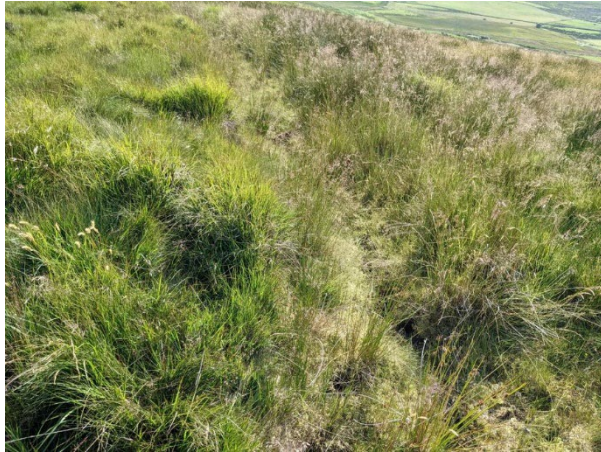
T18 (334128, 580901)

- Survey undertaken to characterise watercourse tributary shown on 1:10,000 scale map and noted absent from 1:25,000 and 1:50,000 scale OS.
- Desktop assessment using LiDAR and aerial imagery identified high number of artificial drainage ditches all draining to a tributary of the Bigholm Sike.
- Site walkover no drainage network at the proposed turbine location. Approximately 100m to the west the ditch became more pronounced. The artificial ditch confluent with a headwater tributary of the Bigholm Sike ~300m to the west. The Bigholm Sike is a natural watercourse channel and is outside the buffer.
- As the mapped ditch is ~100m from the proposed turbine and is also artificial, no specific consideration is required.
- Surrounding habitat noted as M25 (modified bog) and where the ditch becomes pronounced may benefit from ditch blocking.
